AFCEC-CX-TY-TR-2014-0005

ANALYSIS OF MULTIPLE-IMPACT BALLISTIC PERFORMANCE OF A TEMPERED GLASS LAMINATE WITH A STRIKE FACE FILM

Michael A. Magrini

February 2014

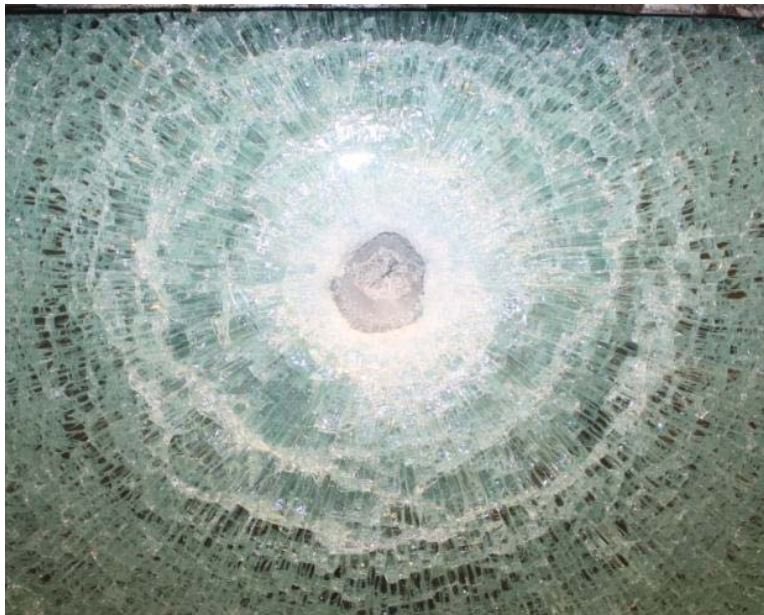
Figure 1. Typical Response of a Tempered Glass Laminate to a Single High Velocity Impact by a Small Arms Rifle Projectile

Figure 1 shows that comminution of glass has occurred and spall was ejected from the strike face resulting in the formation of a crater. Radial and circumferential cracks also formed throughout the strike face as a result of the impact. However, the contributions of these mechanisms to defeating a projectile are mainly realized during the first impact as subsequent impacts find the glass shattered and unable to absorb the same amounts of energy as during the first impact. The radial and circumferential cracks have created loose fragments on the strike face and a subsequent impact could easily displace material not only at the point of impact, but also across a large area of the strike face as seen in Figure 2.

The desire to use low-cost glass laminates for large structures requiring various levels of blast and ballistic protection has increased significantly in recent years. When the threat level is not extremely high and budget concerns preclude the use of high performance materials for glazings, tempered glass laminates are widely available and can also be custom manufactured by numerous entities around the world. The tempered glass is typically used in conjunction with polymer interlayers to enhance impact resistance, thermal properties, and provide an improvement in safety should the window(s) shatter. Tempered glass provides ballistic resistance through compressive strength and energy absorption as the glass fractures as well as causing erosion in the penetrating projectile. Figure 1 shows a typical impact to a tempered glass laminate by a small arms rifle projectile.

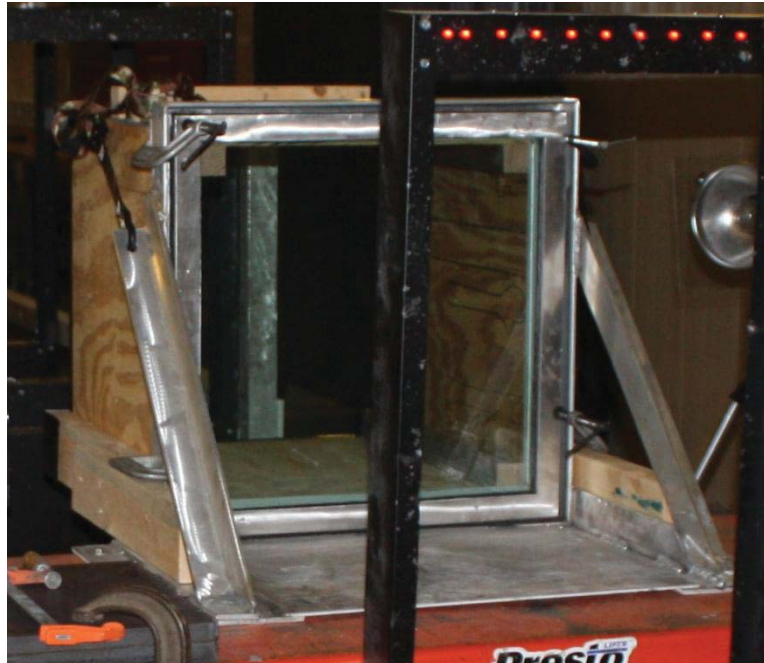
Ballistic testing was conducted at the Air Force Civil Engineer Center (AFCEC) Ballistic Test Facility at Tyndall AFB, FL. A universal receiver powder gun was used to fire the threat projectiles. Data collection was focused on four areas: strike velocity (to ensure consistency from one test to the next), exit velocity, mass of spall ejected from the strike face, and crater analysis. Each sample was rigidly mounted to the test frame by clamping an aluminum plate in four corners, as shown in Figure 4. The plate and frame effectively provided a 1-in bite on each sample.

Figure 4. Rear View of the Test Frame

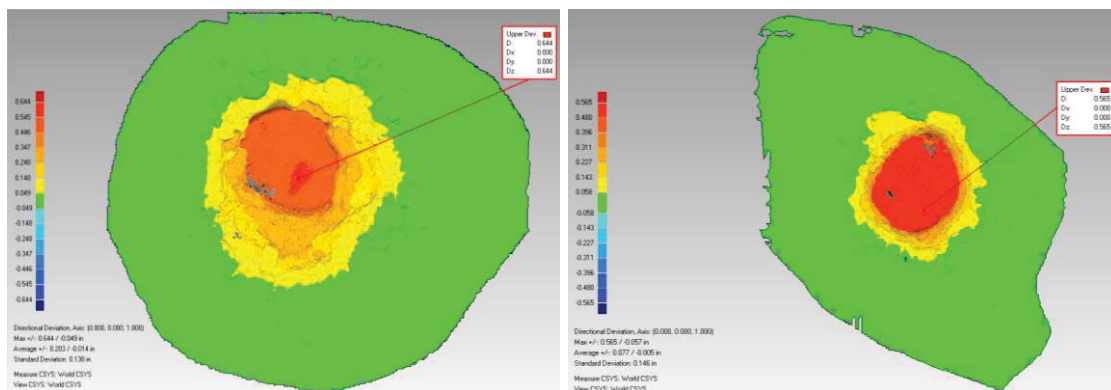
Analysis of the craters was conducted solely through the 3-D digital crater replicas created by the laser scanner. Topographical analysis was conducted initially to compare the geometries between laminate designs and study any other distinguishable characteristics of the craters. As shown in Figure 14, the craters created in filmless samples tended to have a more conical shape while the craters created in samples with film on the strike face had a more cylindrical shape with steep edges. It was hypothesized that the film constrained the glass and forced it to interact with itself and the projectile as it penetrated through the sample. This resulted in the glass having no other direction to travel except the direction that the projectile entered, thus ejecting spall straight away from the strike face rather than in a 30 to 45 degree cone as was observed in the filmless sample. The orange and red areas depict the front face of the polymer interlayer and the location of penetration is actually visible as a darker spot in the left image.

Figure 14. Topographical Representations of the First Impact on a Sample without Film (left) and a Sample with Film (right). Green Represents the Surface and Red Represents the Bottom of the Crater

Figure 14. Notice the characteristics of the edges on the crater created in the sample with a strike face film. The flat portion on the bottom is the front face of the polymer interlayer and corresponds with the red area in Figure 14.
